Home Inspection Report

1234 School House Road
Yourtown, US 12345

Prepared for: Bob Smith

Prepared by: Your Company Name Here
9600 Colerain Ave., Suite 110
Cincinnati, OH 45251
OH License #12345

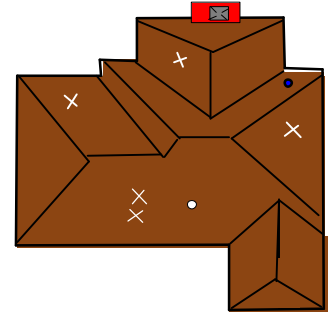
Roof Diagram

Material: *Fiberglass shingle - Nail popping through shingle surface in various locations causing potential water intrusion (see diagram above marked "x")*

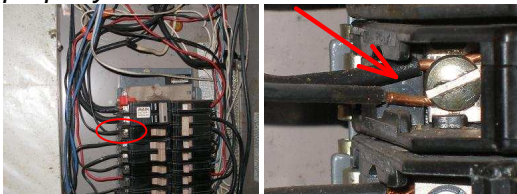
Breakers: Copper - Double taps are present at breakers. These circuits need to be moved to their own circuit breaker and cannot share a breaker. It is recommended that a qualified electrician inspect the new circuits and properly connect the new circuits to an individual breaker for each circuit

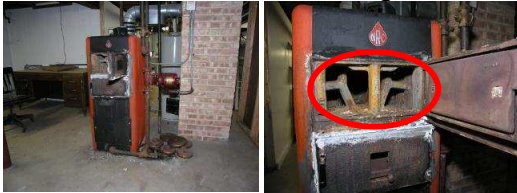
Heating System Operation: *Recommend replacement - Boiler system is antiquated and lacks safety features found on newer units including non-sealing combustion chamber which can cause health issues*
