Sample Inspection Report

1234 School House Road
Yourtown, US 12345

This agreement and subsequent report is for the property inspected at 1234 School House Road, Yourtown, US 12345 on 9/30/12.

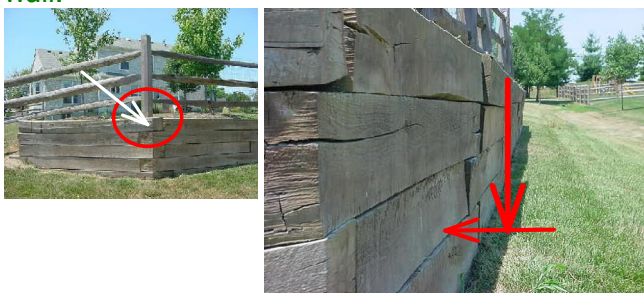
1. **Walks:** Concrete
2. **Steps/Stoops:** Concrete
3. **Patio:** Pebble top
4. **Deck:** Treated wood: The deck has been built below acceptable building standards and is not safe in its current state. Recommend further evaluation and estimate to bring deck up to an acceptable building standard.
5. **Balcony:** Concrete
6. **Porch:** Concrete
7. **Vegetation:** Shrubs with some weeds
8. **Retaining Walls:** Railroad ties: The wall is showing signs of movement, but appears to be stable at this time. A qualified contractor is recommended to evaluate and estimate repairs to maintain the wall.

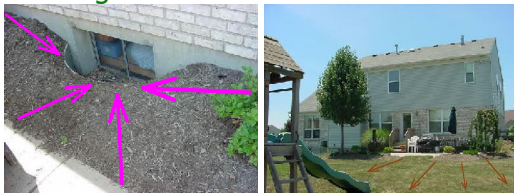
9. **Basement Stairwell:** Concrete
10. **Grading:** Moderate slope: The grade and landscaping materials are too high and extend above the window well at the Northeast rear of the home. Recommend that the grade be reduced or the metal window well soil retainer be replaced with a taller unit to keep the mulch and soil beds from washing into the well.

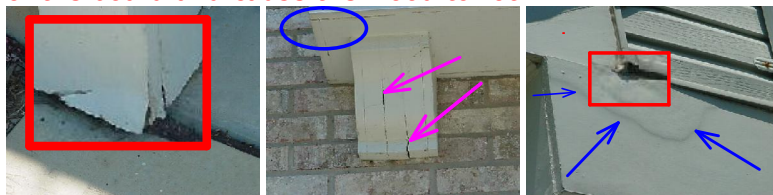
1. Water damage to trim wood at either side of garage door from moisture wicking into the finished particle board. The surface is starting to delaminate. Recommend repair/replacement of the trim boards and silicone seal wood that is in contact with concrete to prevent wicking.

2. The wood window boxes have water damage and will require repair/replacement. The wood has started to separate at the supports and at the corners of the window boxes.

3. The trim board at the southwest corner of the porch has water damage due to water penetration. The trim board extends out creating a ledge allowing water to collect on the top edge of the board and cause the wood to rot.

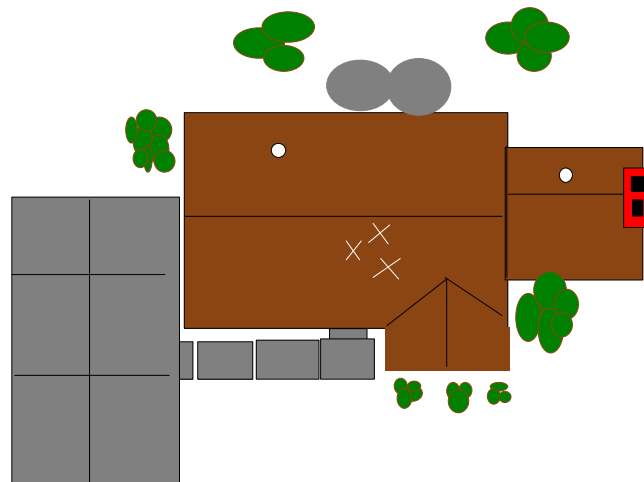
Main Roof Surface

1. **Method of Inspection:** On the roof
2. **Unable to Inspect:** 30%: Height of the roof
3. **Material:** Fiberglass shingle: **Missing roof shingles from wind damage as marked "x" in diagram. Repairs are required.**
4. **Type:** Gable

5. **Main Roof Surface Material:** Fiberglass shingle: Missing roof shingles from wind damage as marked "x" in diagram. Repairs are required.
6. **Leader/Extension:** Underground conductors: Reconnect to downspout where pulling loose.
