# Sample Inspection Report

1234 School House Road  
Yourtown, US 12345

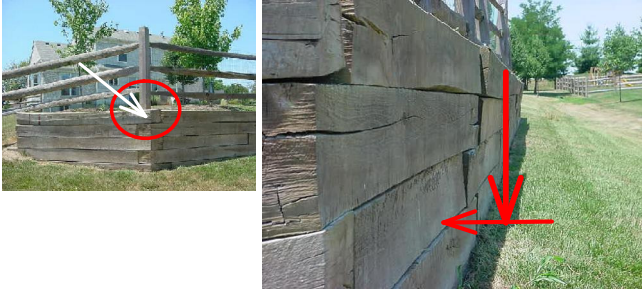
**Retaining Walls:** Railroad ties - The wall is showing signs of movement, but appears to be stable at this time. A qualified contractor is recommended to evaluate and estimate repairs to maintain the wall.

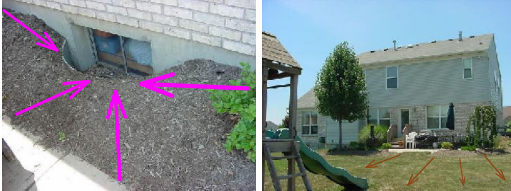
**Grading:** Moderate slope - The grade and landscaping materials are too high and extend above the window well at the Northeast rear of the home. Recommend that the grade be reduced or the metal window well soil retainer be replaced with a taller unit to keep the mulch and soil beds from washing into the well.

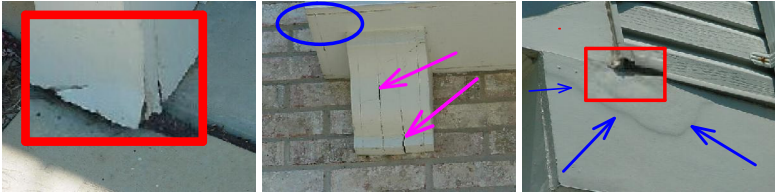
1. Water damage to trim wood at either side of garage door from moisture wicking into the finished particle board. The surface is starting to delaminate. Recommend repair/replacement of the trim boards and silicone seal wood that is in contact with concrete to prevent wicking.
2. The wood window boxes have water damage and will require repair/replacement. The wood has started to separate at the supports and at the corners of the window boxes.
3. The trim board at the southwest corner of the porch has water damage due to water penetration. The trim board extends out creating a ledge allowing water to collect on the top edge of the board and cause the wood to rot.
