# Inspection Report

1234 School House Road  
Yourtown, US 12345

John Smith  
1234 School House Road  
Page 1 of 16

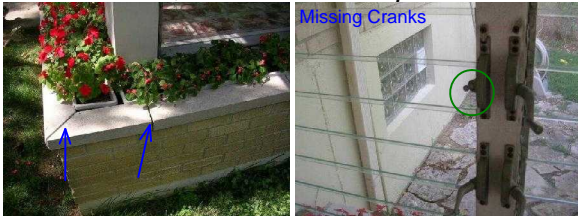
3. Patio/Enclosure: *Ceramic tile, Brick, Aluminum windows - Loose limestone wall caps, Missing screens and some cranks, Lubricate as required*

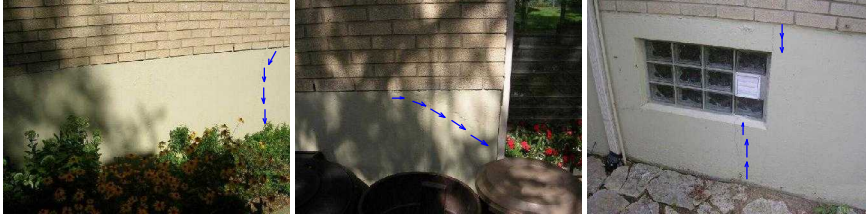
Structure Type: *Wood frame*  
Foundation: *Poured concrete - Common cracks noted near windows, Spalled foundation corners noted*  
Differential Movement: *Differential settlement present - Cracks will require monitoring*  
Beams: *Steel I-Beam*  
Joists/Trusses: *2x10*  
Piers/Posts: *Not visible*  
Floor/Slab: *Poured slab*  
Stairs/Handrails: *Wood stairs with wood handrails - Handrails missing to lower level from kitchen(Safety)*  
Subfloor: *Plywood*

9. Foundation: *Poured concrete - Common cracks noted near windows, Spalled foundation corners noted*

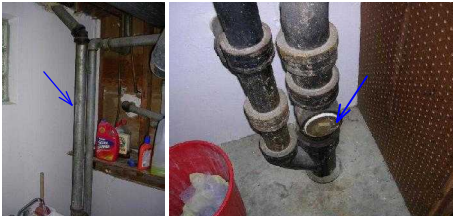
Drain Pipes: *Cast iron, Galvanized - Slow draining noted at Tub. A licensed plumber is recommended to evaluate and estimate corrections, Galvanized drainpipe present- Galvanized piping corrodes from inside causing decreased flow rates and will eventually require updating. Noted new clean out cap which may indicate access was needed to clear drain clog*

14. Drain Pipes: *Cast iron, Galvanized - Slow draining noted at Tub. A licensed plumber is recommended to evaluate and estimate corrections, Galvanized drainpipe present- Galvanized piping corrodes from inside causing decreased flow rates and will eventually require updating. Noted new clean out cap which may indicate access was needed to clear drain clog*

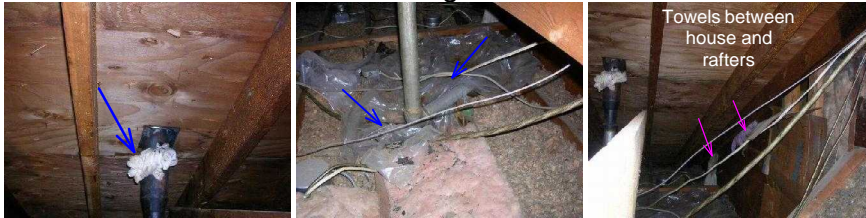
Moisture Penetration: *Previous water penetration noted - Previous water penetration noted at plumbing stack penetration with plastic in attic to catch water and towels wedged between house and rafter- no current leaking detected - Monitor*

20. Partial house-Lower Attic Moisture Penetration: *Previous water penetration noted - Previous water penetration noted at plumbing stack penetration with plastic in attic to catch water and towels wedged between house and rafter- no current leaking detected - Monitor*

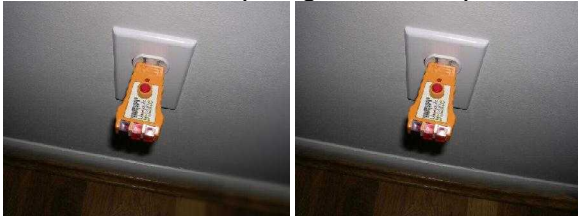
Interior Outlets: *110 VAC - Reversed polarity determined at outlet receptacle- requires repair, Open ground exists at several 3prong outlet receptacles*

5. Interior Outlets: *110 VAC - Reversed polarity determined at outlet receptacle- requires repair, Open ground exists at several 3prong outlet receptacles*

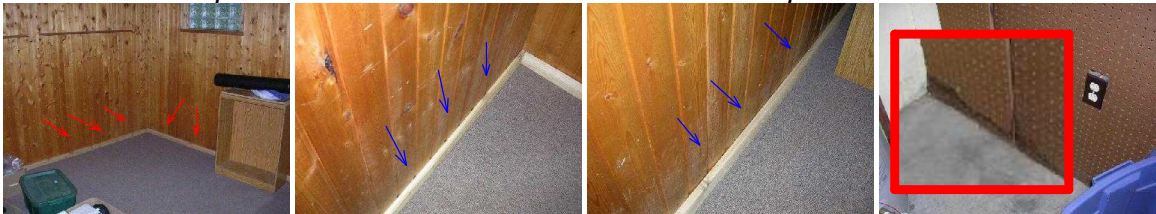
7. Main Basement Moisture Evidence: *Note - Suspected mold present along perimeter finished walls at left and rear elevations. Further investigation behind finishes may uncover hidden problems not visible in this visual inspection. Mold conditions can cause acute and chronic health concerns and should be remediated. Corrections may include remediation protocols provided by an environmental hygienist for the suspected mold conditions and qualified remediation contractors to make required corrections.*
